بيوت أحياء القاهرة القديمة  
في القرن التاسع عشر

19<sup>th</sup> CENTURY HOUSES OF OLD CAIRO QUARTERS

Salah Zaky Said

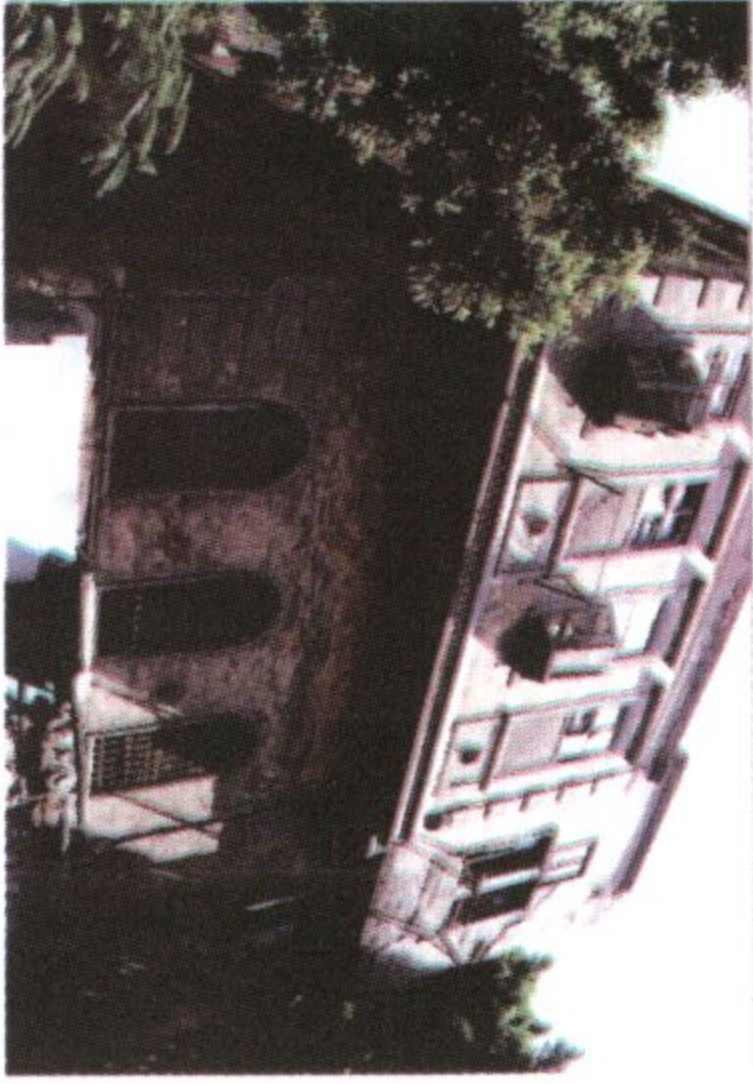
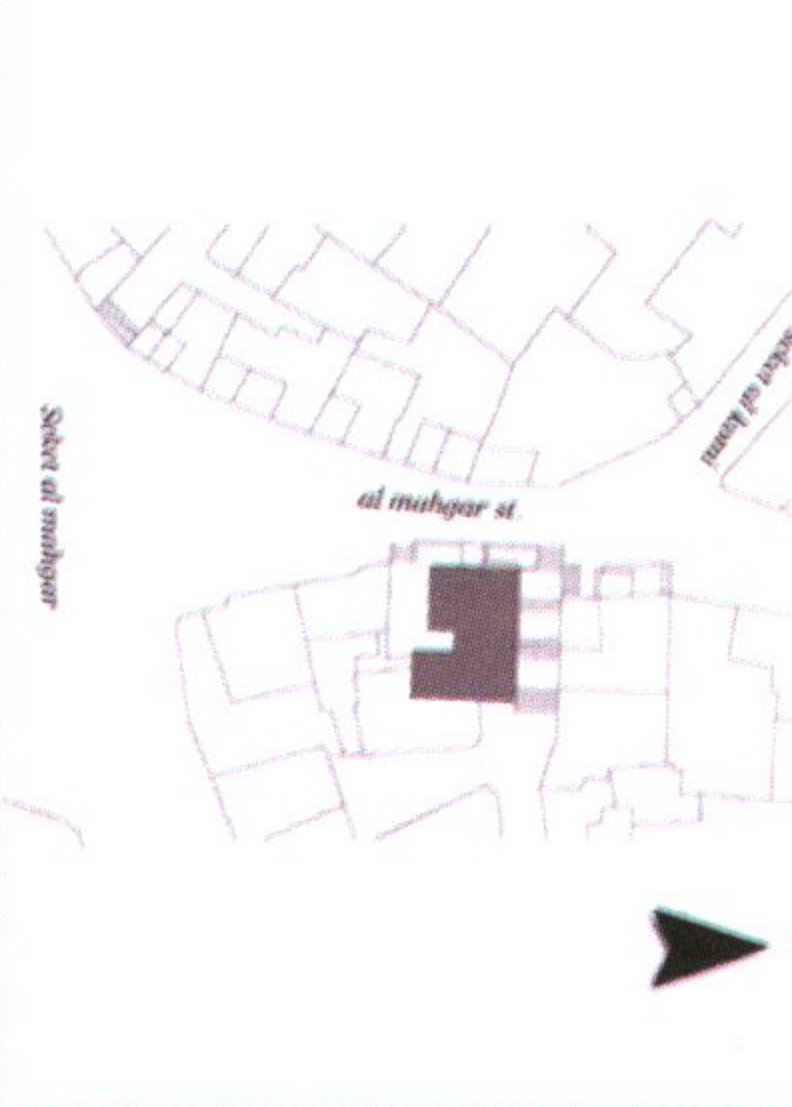
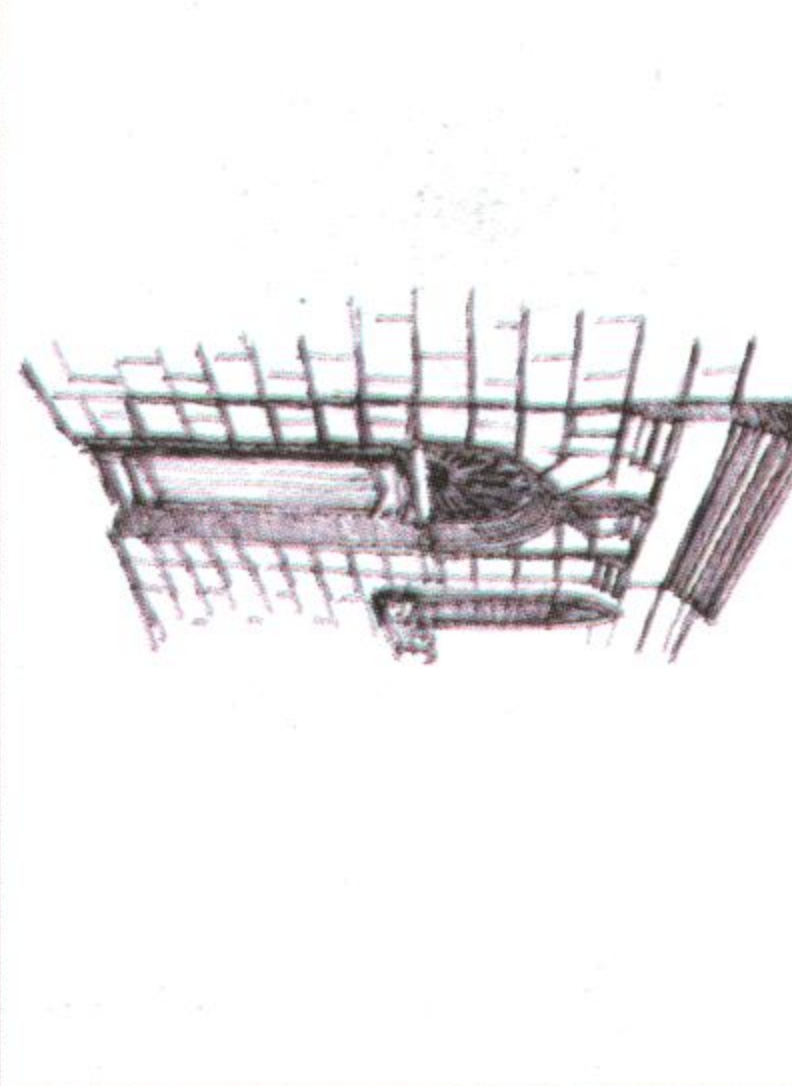
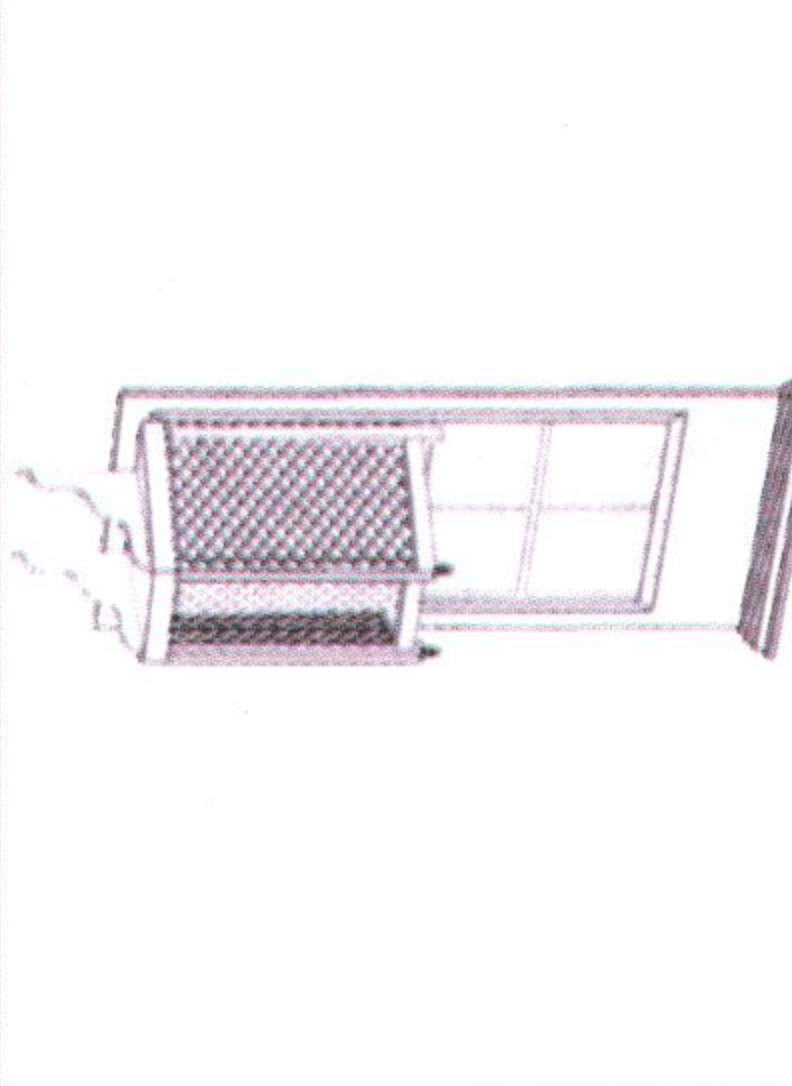
Foundation date: late 19th century. Brief description: The main entrance is 1.6 m. higher than al-Mahgar St. Accessed through the stepped Hant Wikalit al-Jami' , the difference in levels is used for three shops opening on al-Mahgar St. The house had three floors above ground, one of them was removed in 1987. Floor area:90 m2. Rehabilitation date:2000 by the author.

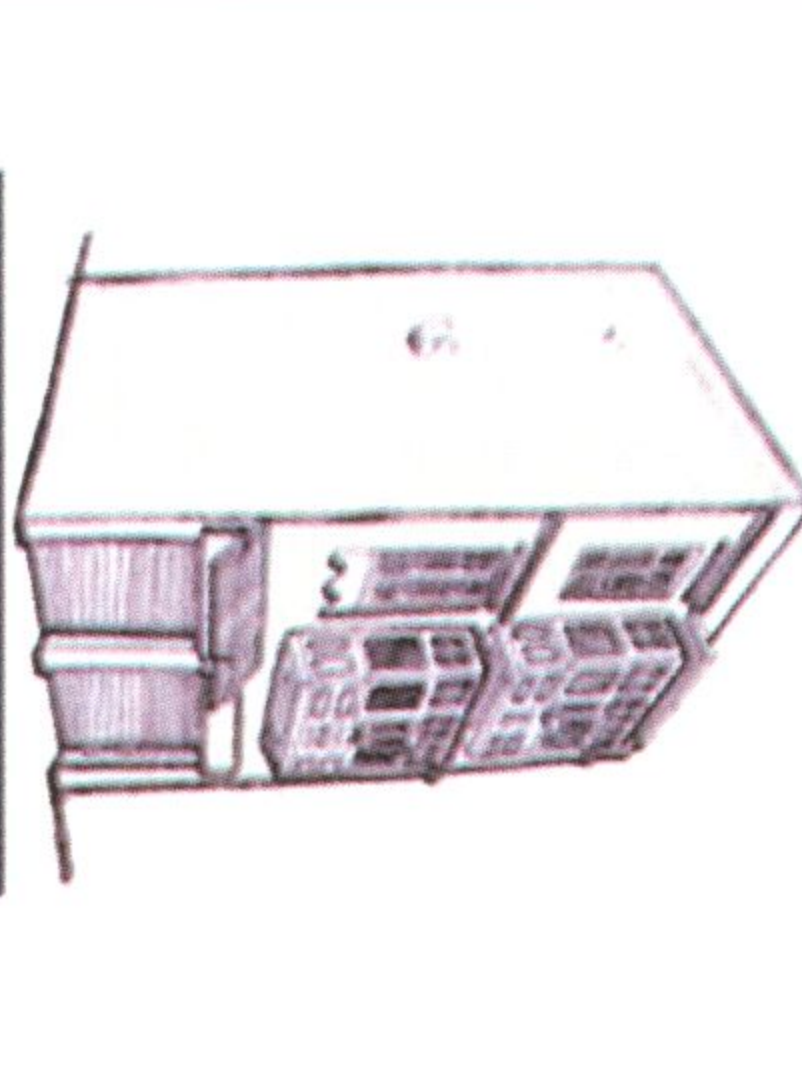
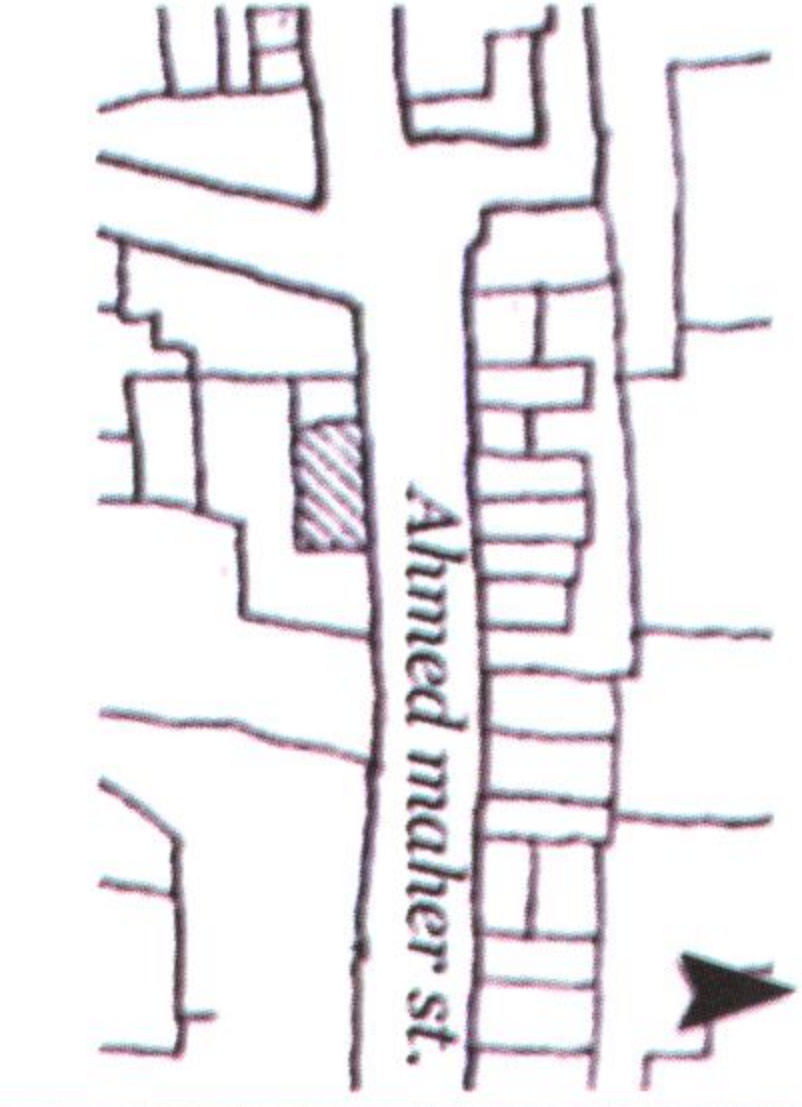
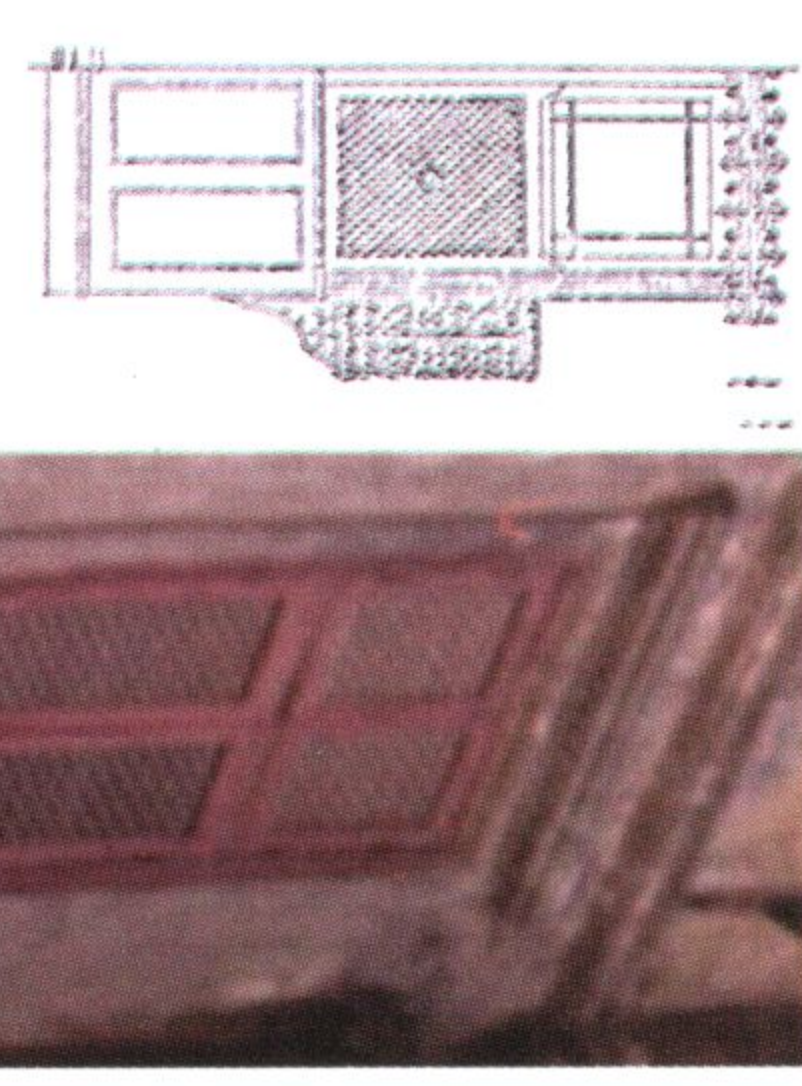
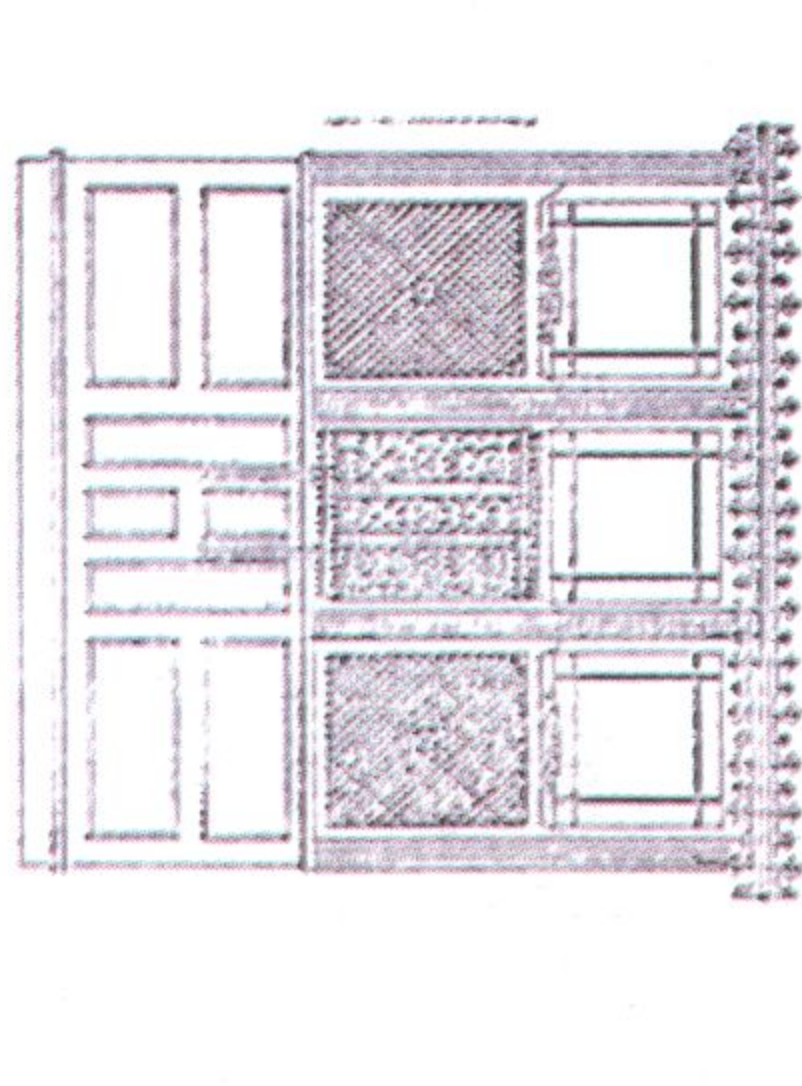
Foundation date: 1890 Brief description: Two floors above the ground floor, each with one small apartment. The apartment is entered through the sala with rooms around. One room is opened as an annex to the main room, has a Mashrabiyya with projecting round small part. Net floor area: 35 m2

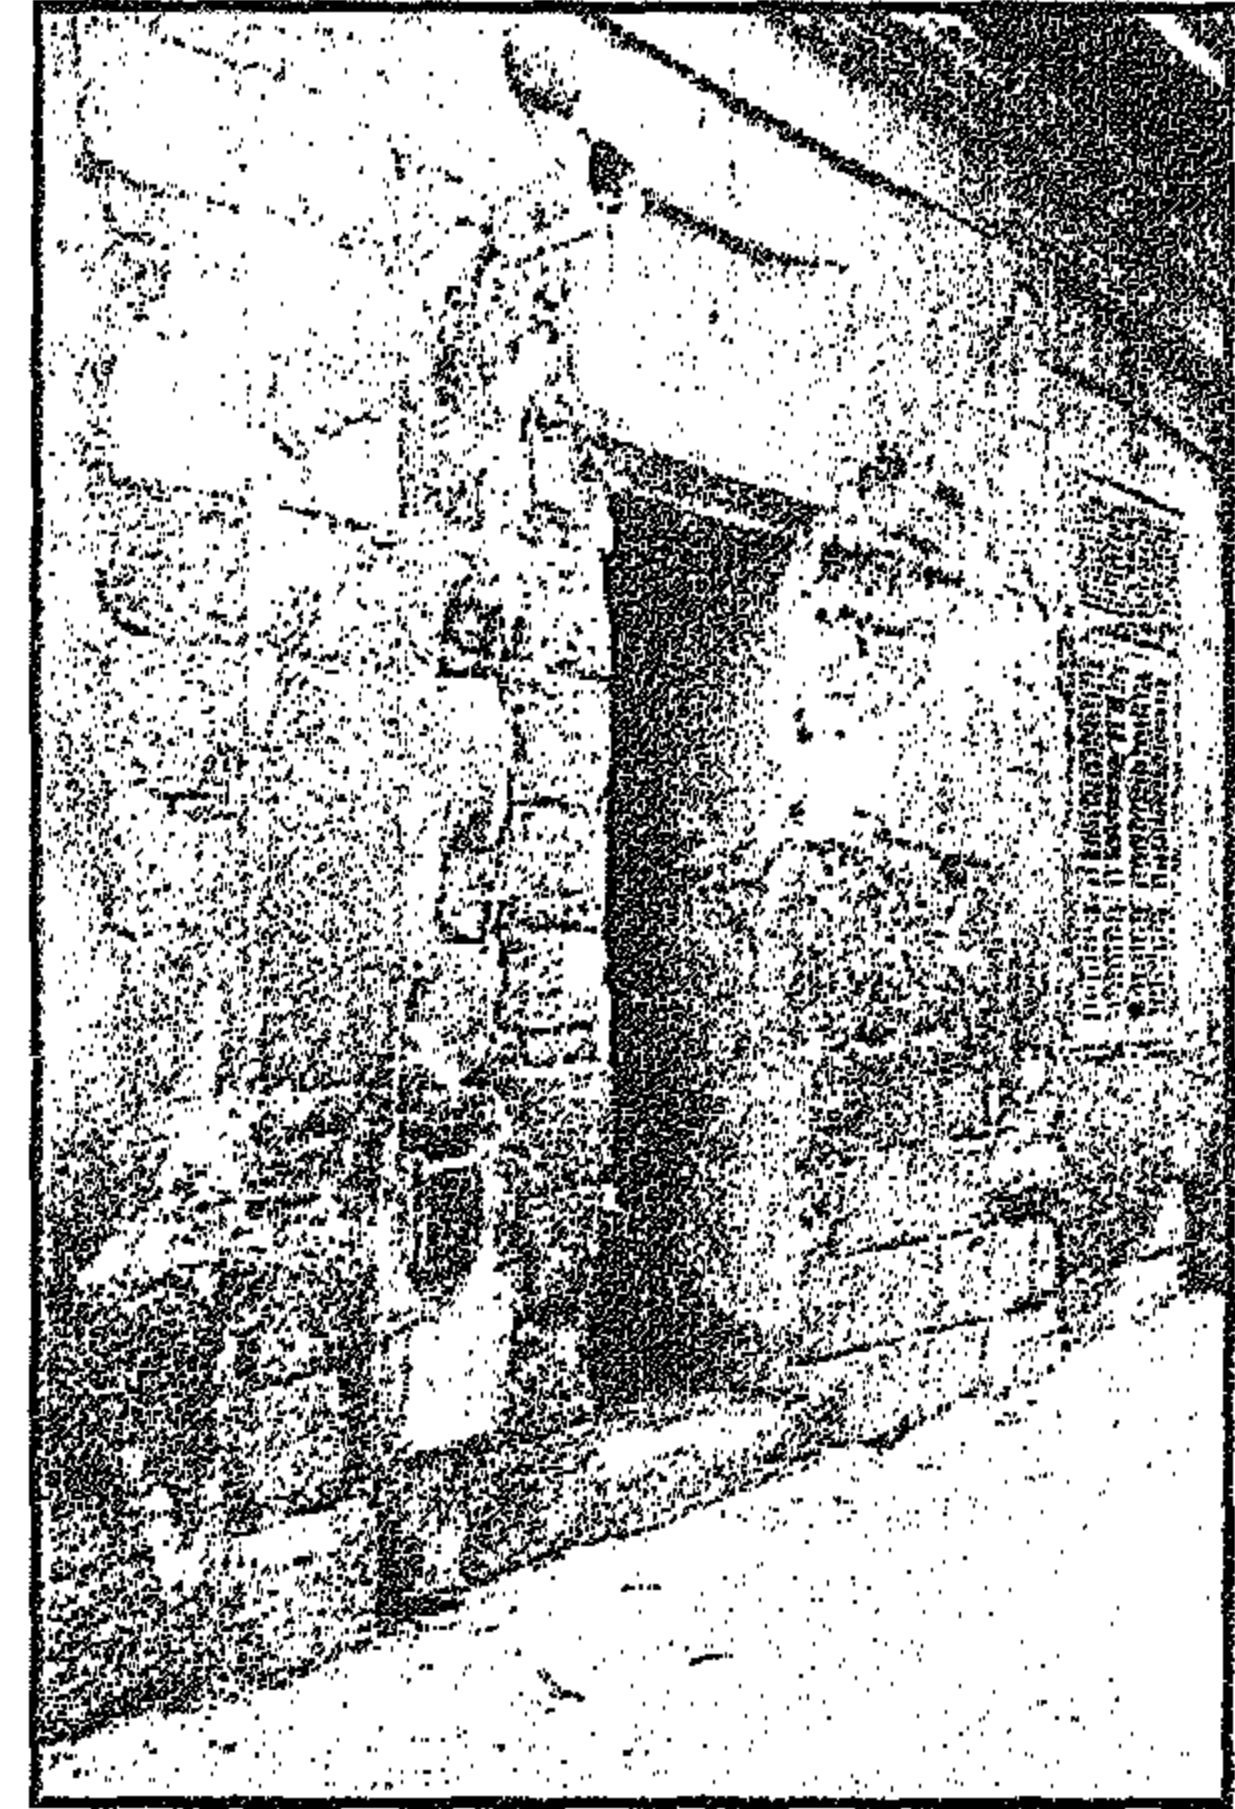
Figure 4-81 Entrance portal before intervention (February 2005)

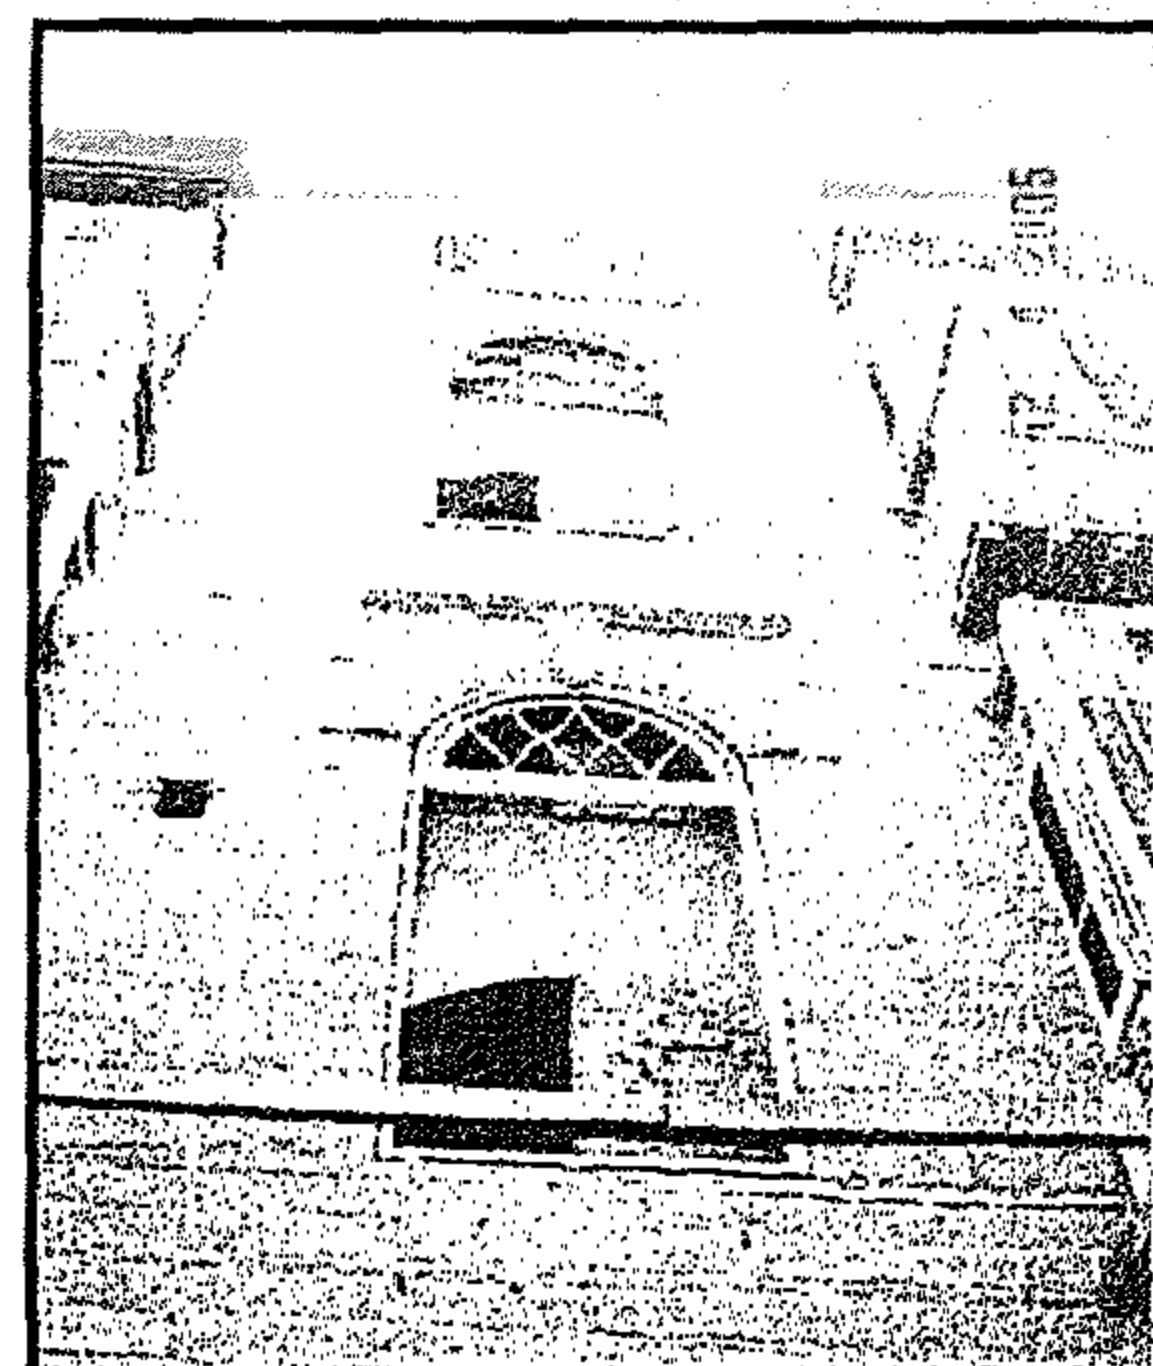
**Figure 4-85** The central portion of the façade at the staircase before intervention (April 2005)

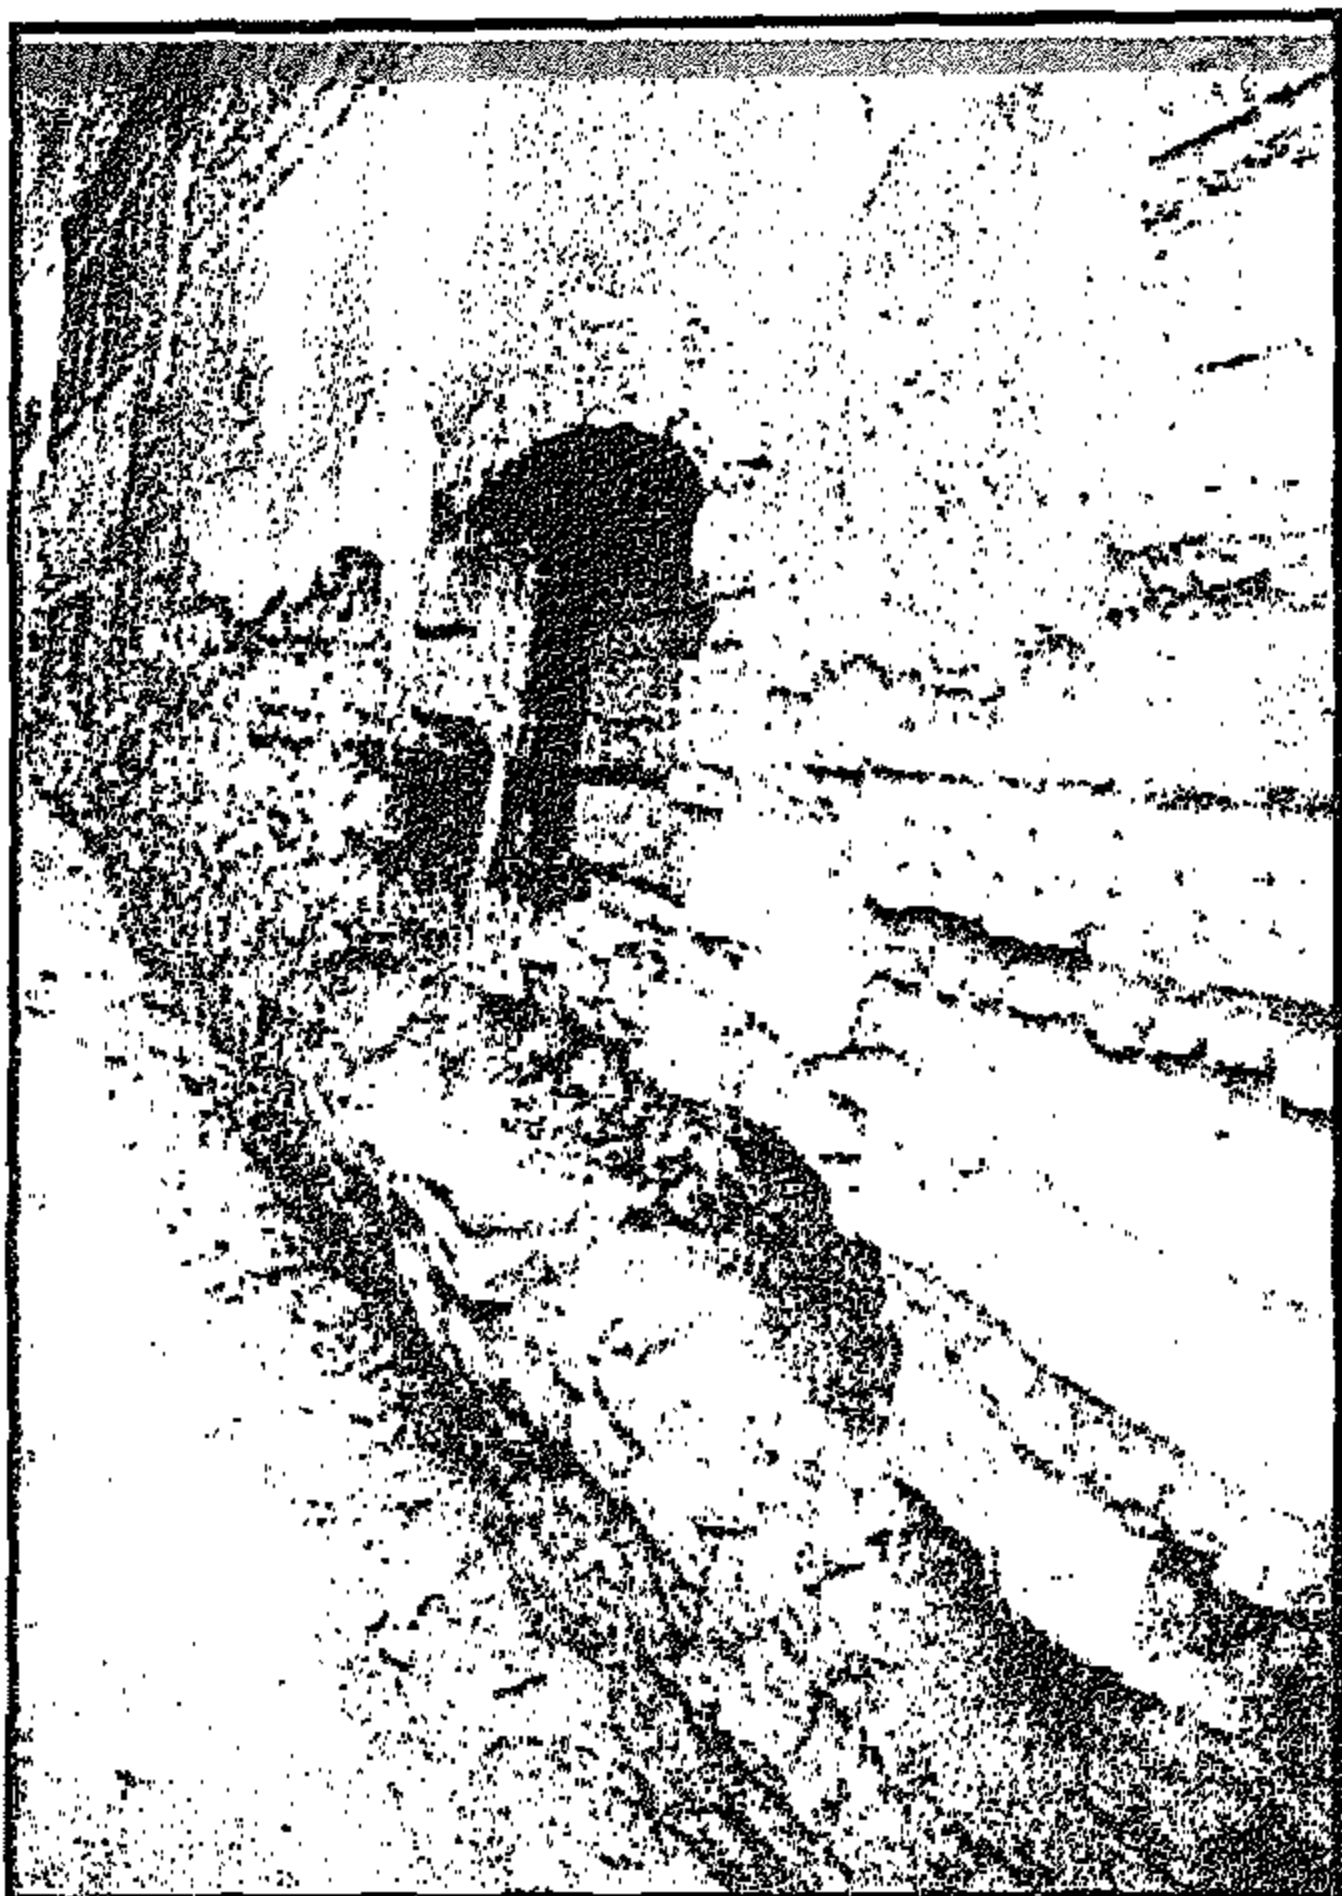
Figure 5-10 Decayed wall of Bayt Sukkar before rehabilitation (1997)

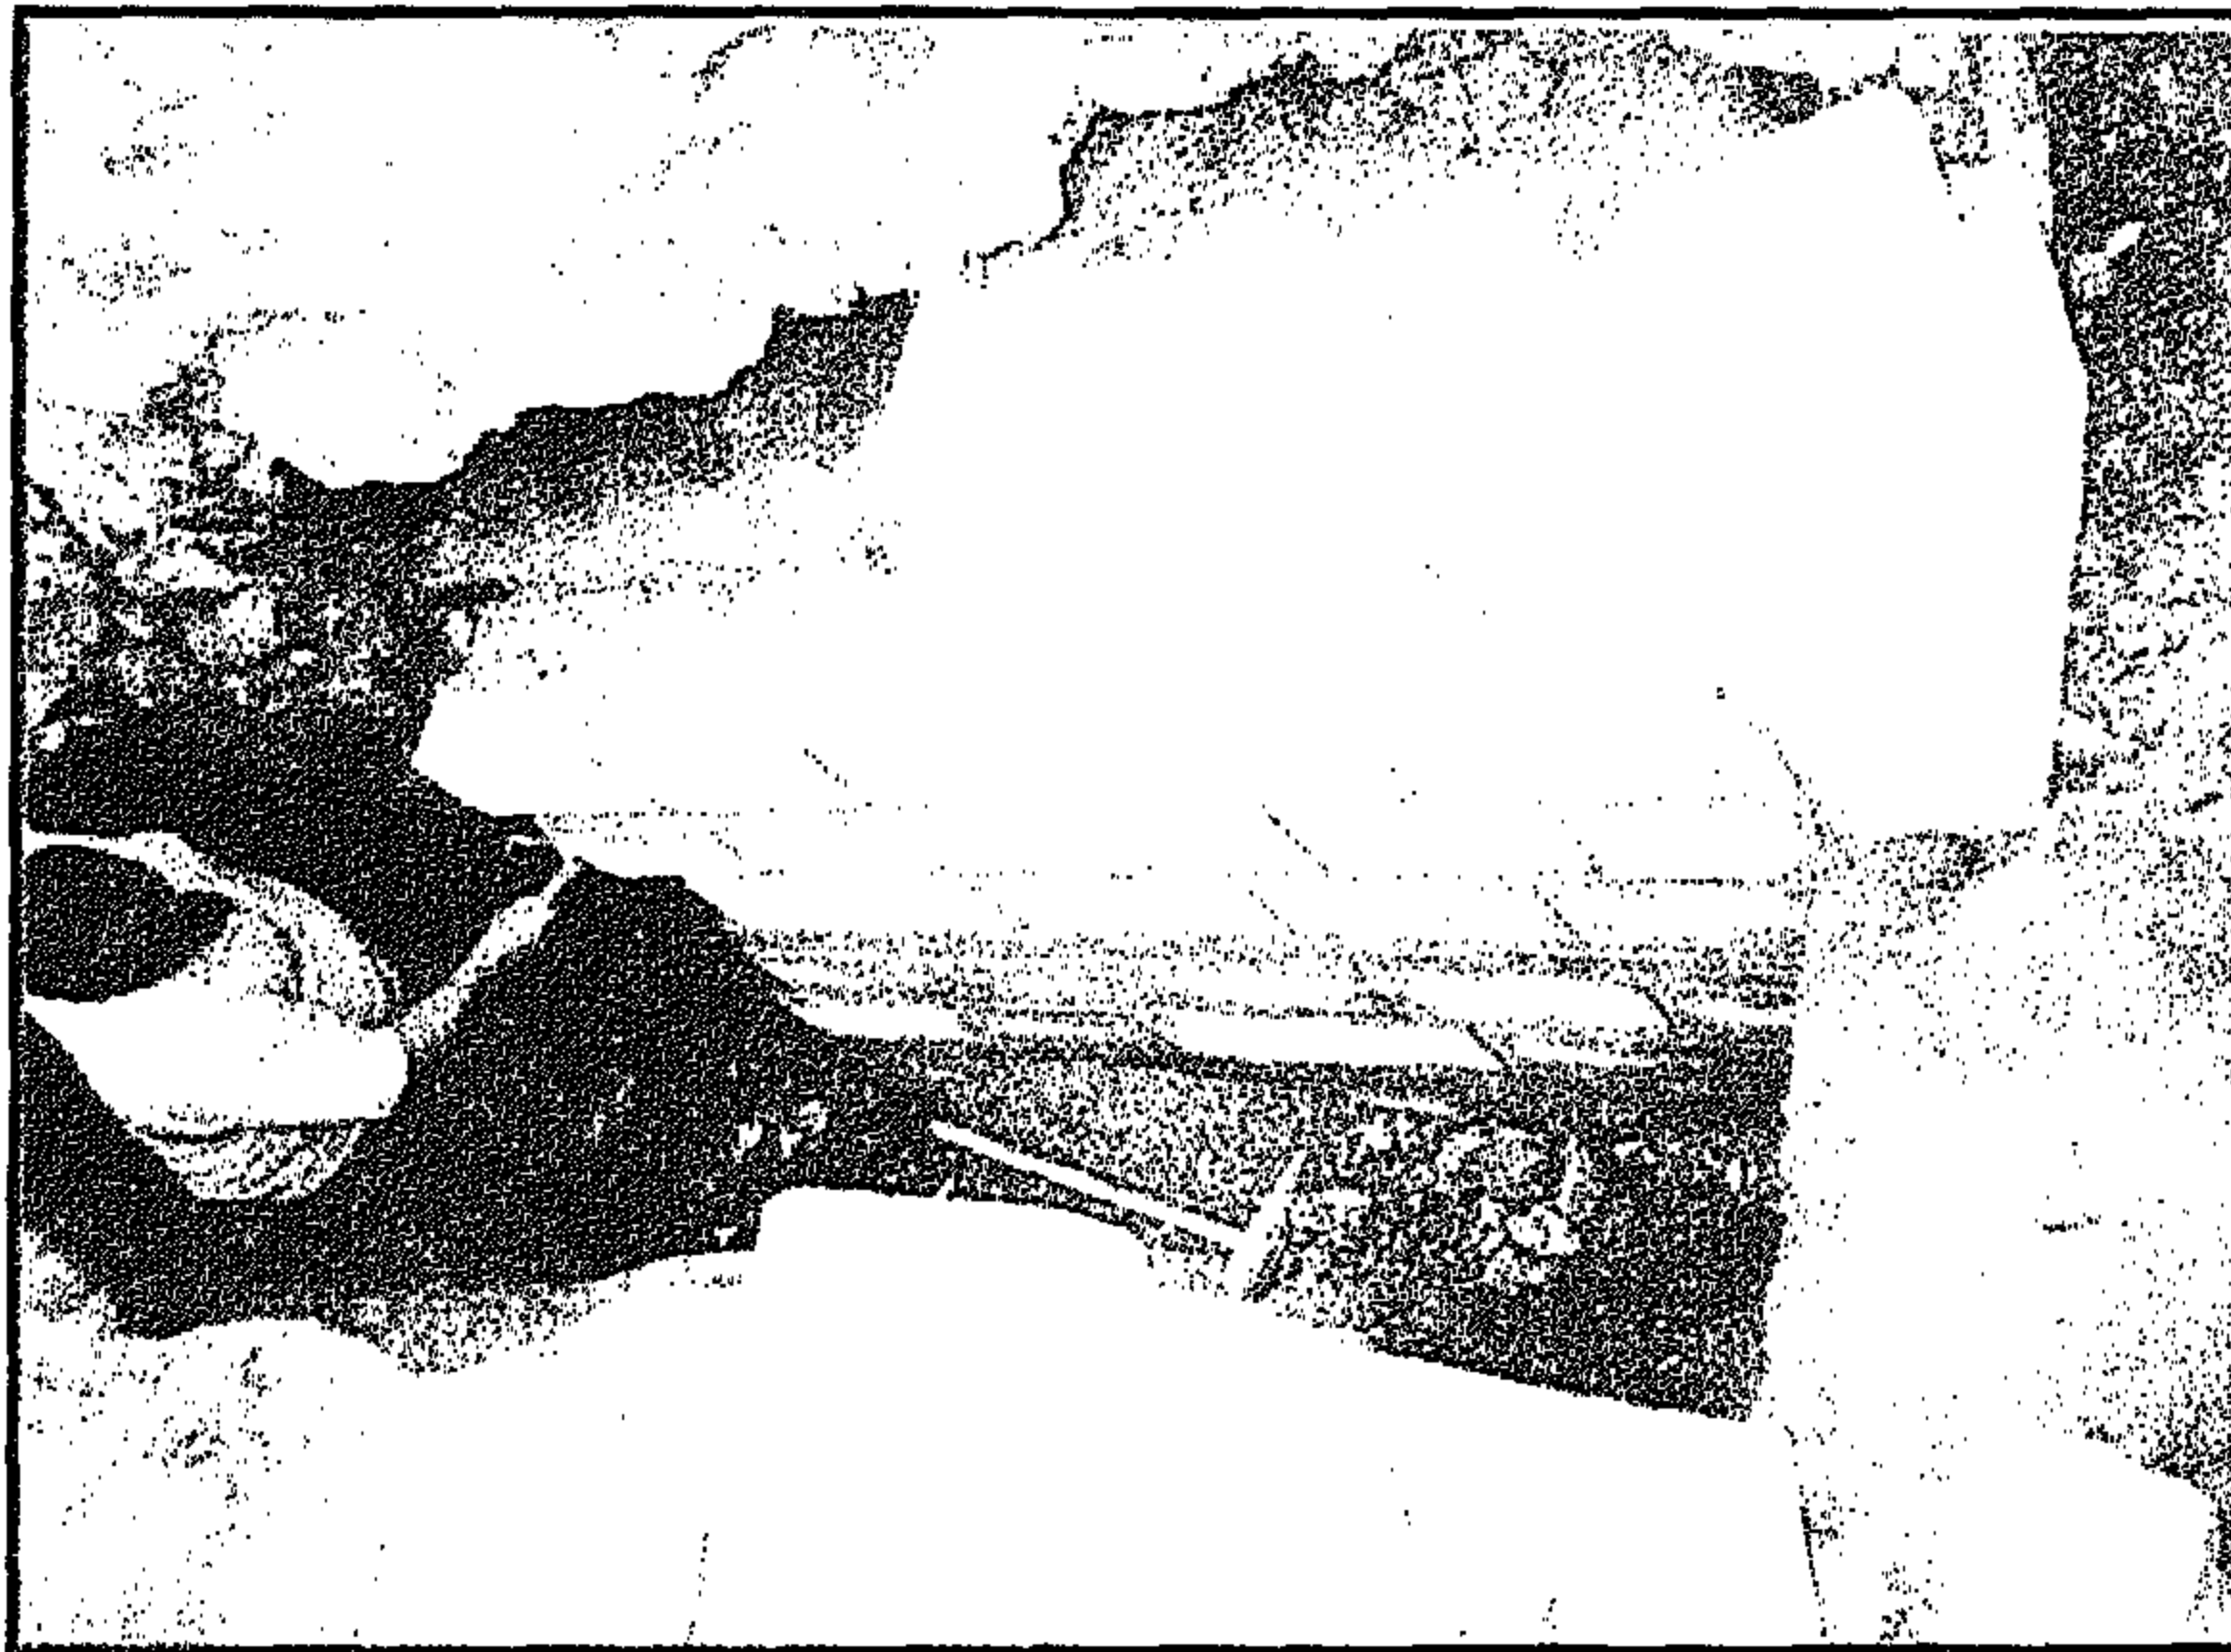
**Figure 5-17** damaged foundation walls being replaced from the ground level up. East wall of Bayt al-Sitt 'Awatif during rehabilitation (December 1998)

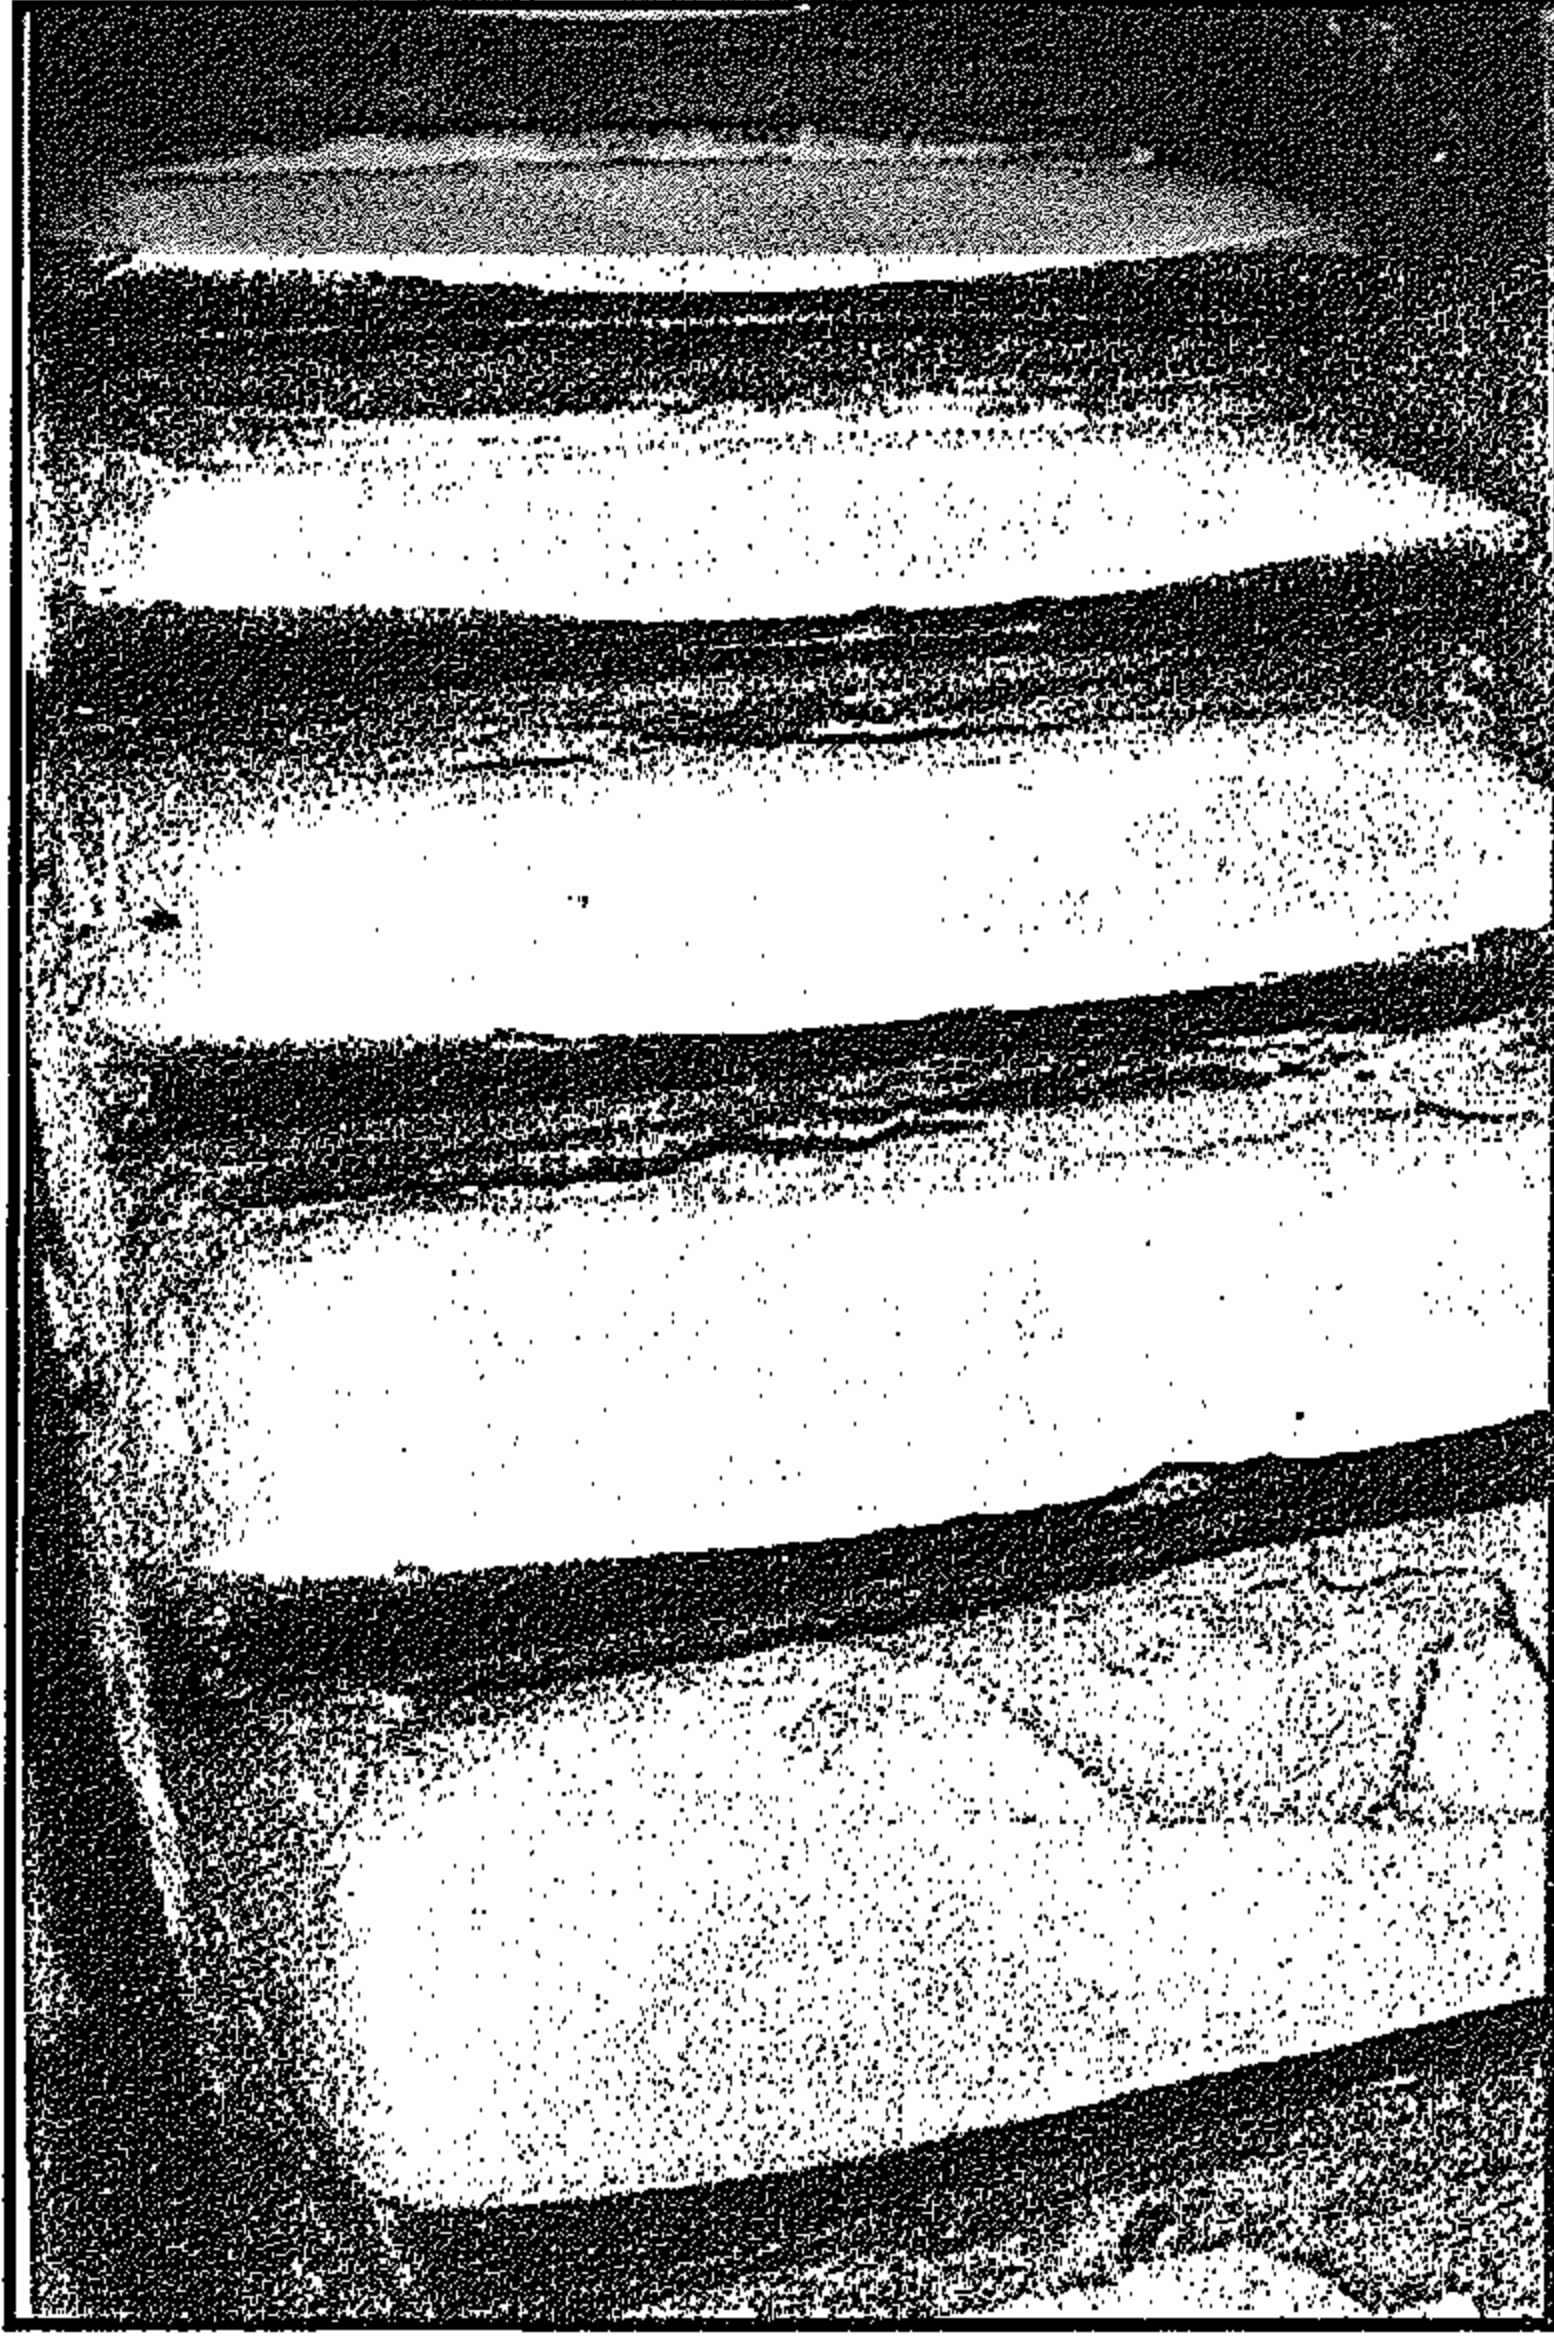
Figure 5-20 Decayed stone steps of Bayt Sukkar

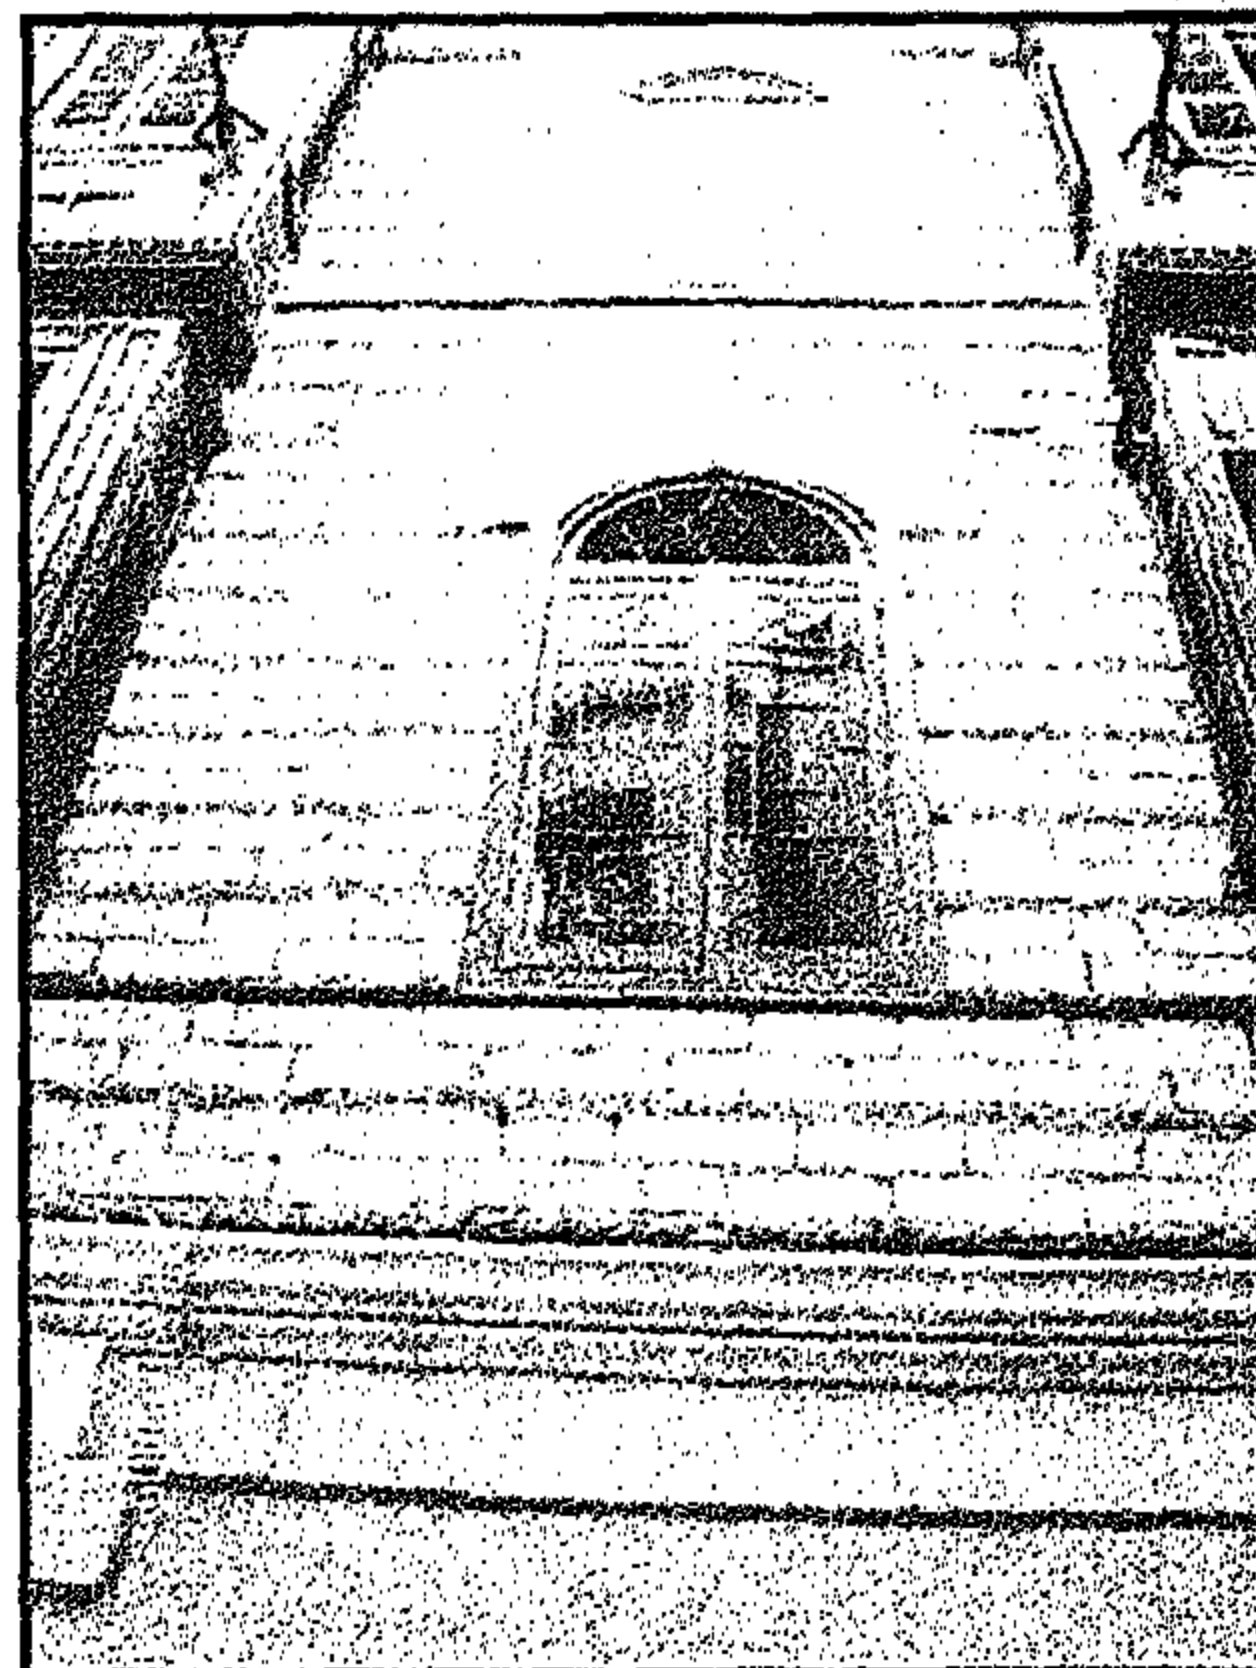
**Figure 5-22** Stone façade in Bayt Abu al-Hasan after cleaning (September 2005)
